# FLIGHT-TEST TEMPERATURE DATA FOR AN ALTAIR-IIIC1 ROCKET MOTOR

*by James L. Raper*  
*Langley Research Center*  
*Langley Station, Hampton, Va.*

NATIONAL AERONAUTICS AND SPACE ADMINISTRATION • WASHINGTON, D. C. • AUGUST 1965

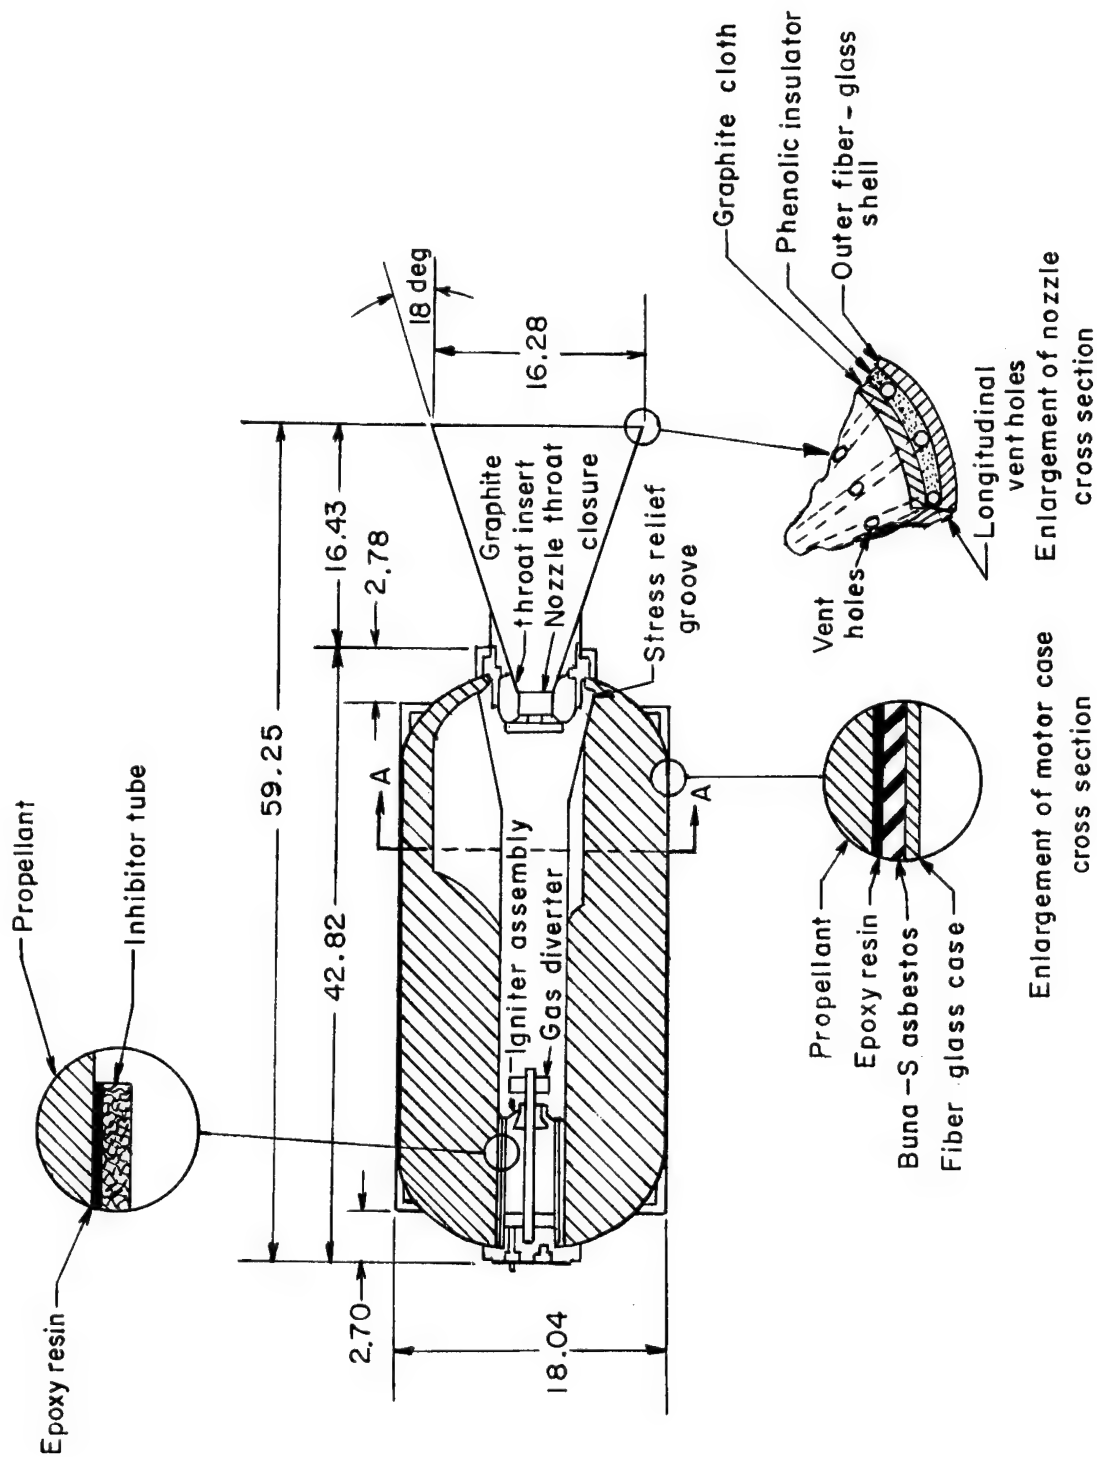
Figure 1.- Altair-IIIC1 motor. All linear dimensions are in inches.

(a) Schematic. (See figure 1(b) for section A-A.)

The Altair IIC1 rocket motor consists basically of a fiber-glass pressure vessel lined with buna-S asbestos insulator, a propellant charge cast into the chamber, and a conical divergent nozzle. Figure 1(a) shows a schematic of the motor assembly. The detail at the top of figure 1(a) shows the location of the previously mentioned inhibitor tube. Figure 1(b) shows the propellant core geometry. Figure 1(c) shows details of the forward dome and cylinder insulator. Note the location on the side wall where boric-acid-loaded synthetic rubber insulation has been added to a previously uninsulated portion of the forward cylinder as previously mentioned. Figure 1(d) shows a cross section of the motor in the aft cylinder area. Note that the insulator is thickest at the points where the propellant first burns through to the chamber wall. The thinnest insulator location is opposite the thickest propellant section. Note also that two strips of boric-acid-loaded synthetic-rubber insulator have been added at the locations opposite minor grain slots to prevent previously experienced chamber-wall hot spots. Figure 1(e) shows details of one of 2 typical places or one of four typical places of the after-cylinder insulator as indicated by the two sections taken through figure 1(d).

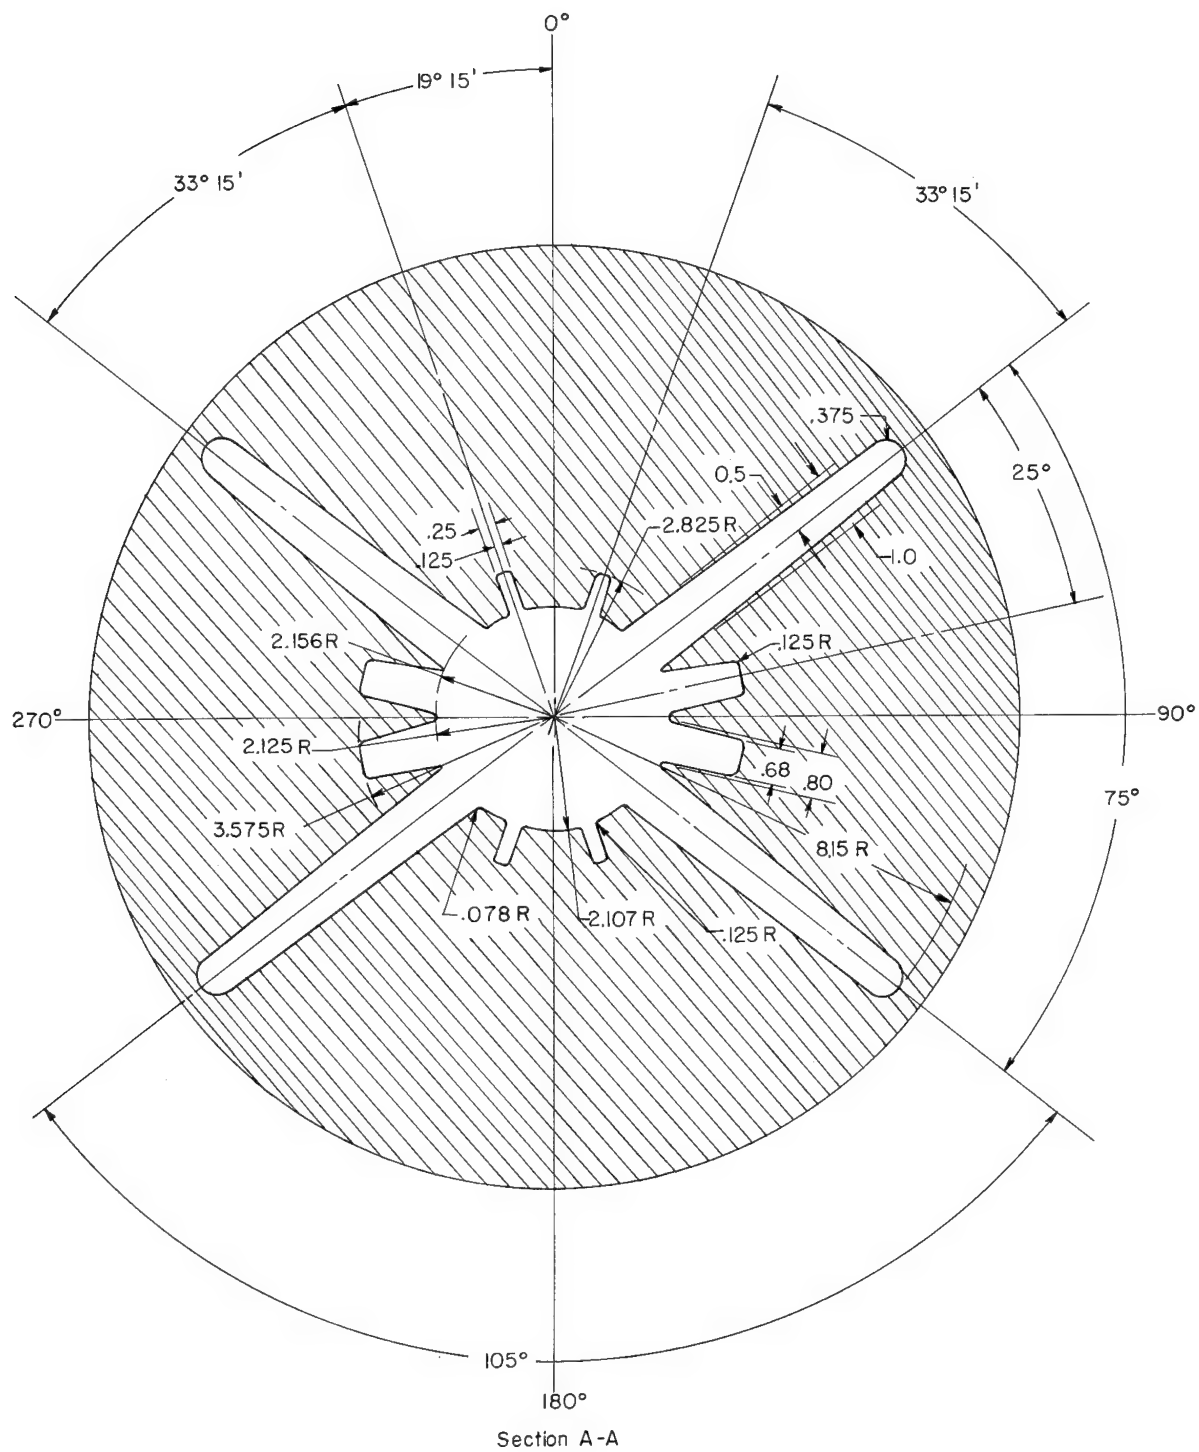
Figure 1.- Continued.

(b) Propellant core geometry.

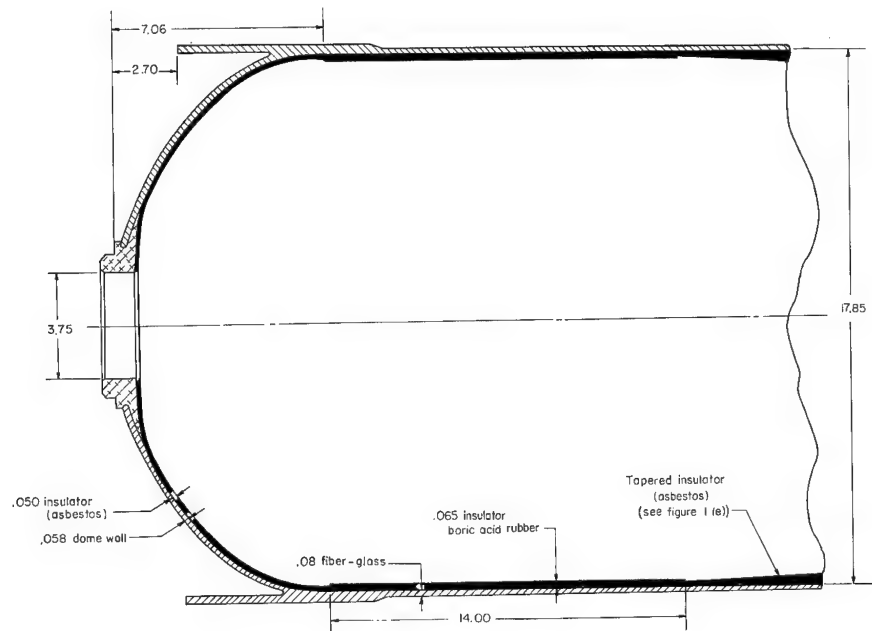
(c) Details of forward dome and cylinder insulator.

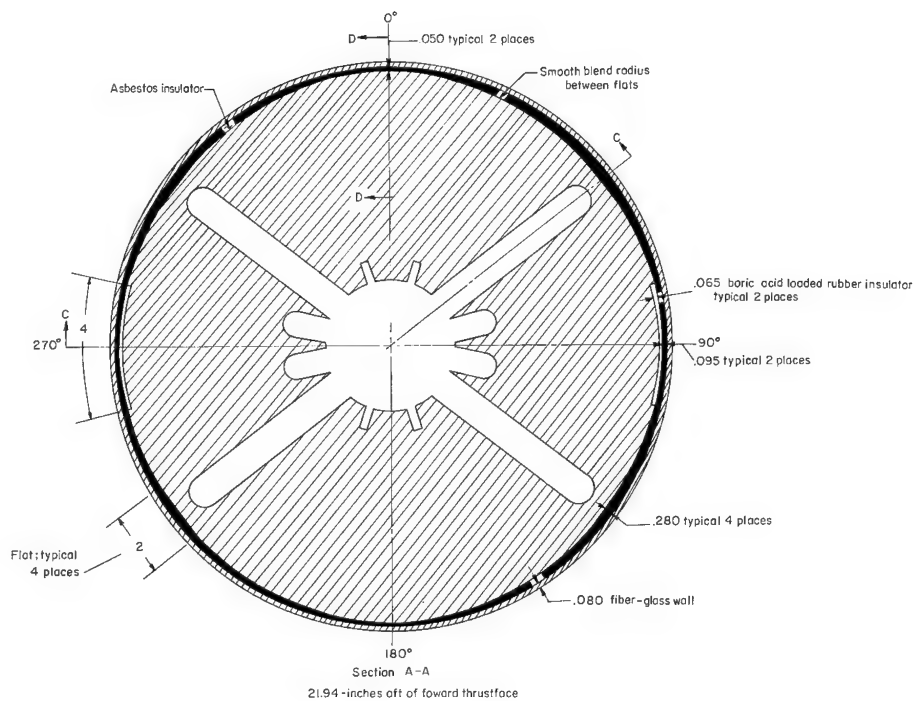
Figure 1.- Continued.

(d) Insulator cross section. (See figure 1(e) for sections C-C and D-D.) Cross section of motor in aft cylinder area.

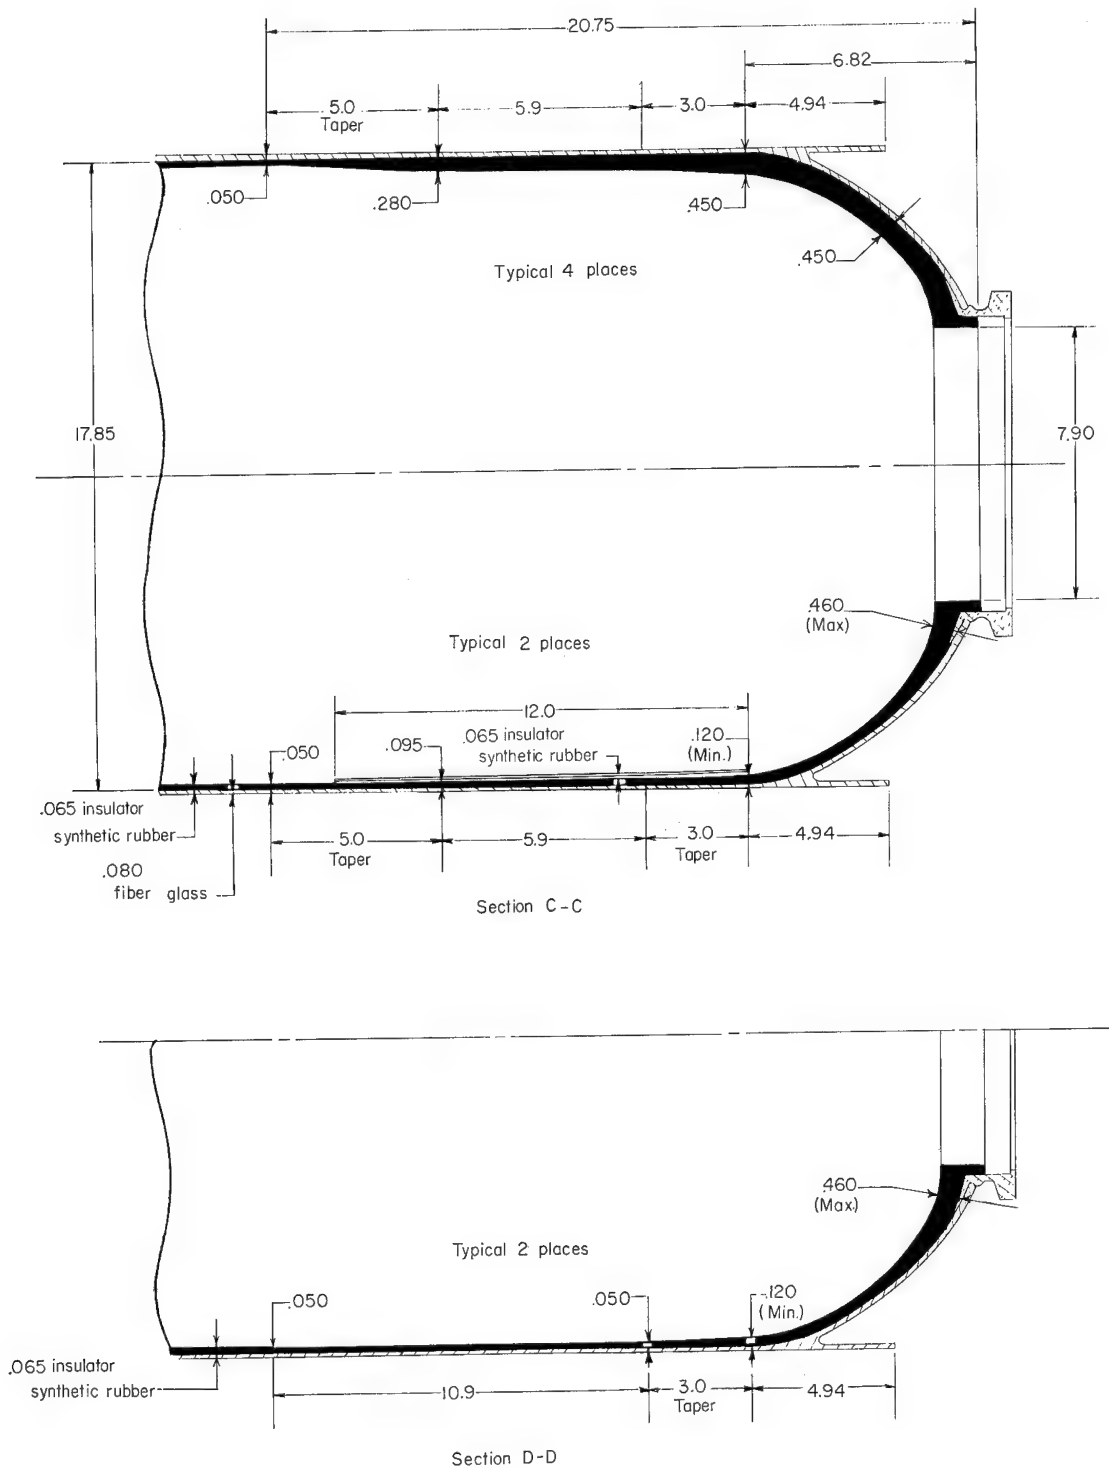
Figure 1.- Concluded.

(e) Aft-chamber asbestos insulator.

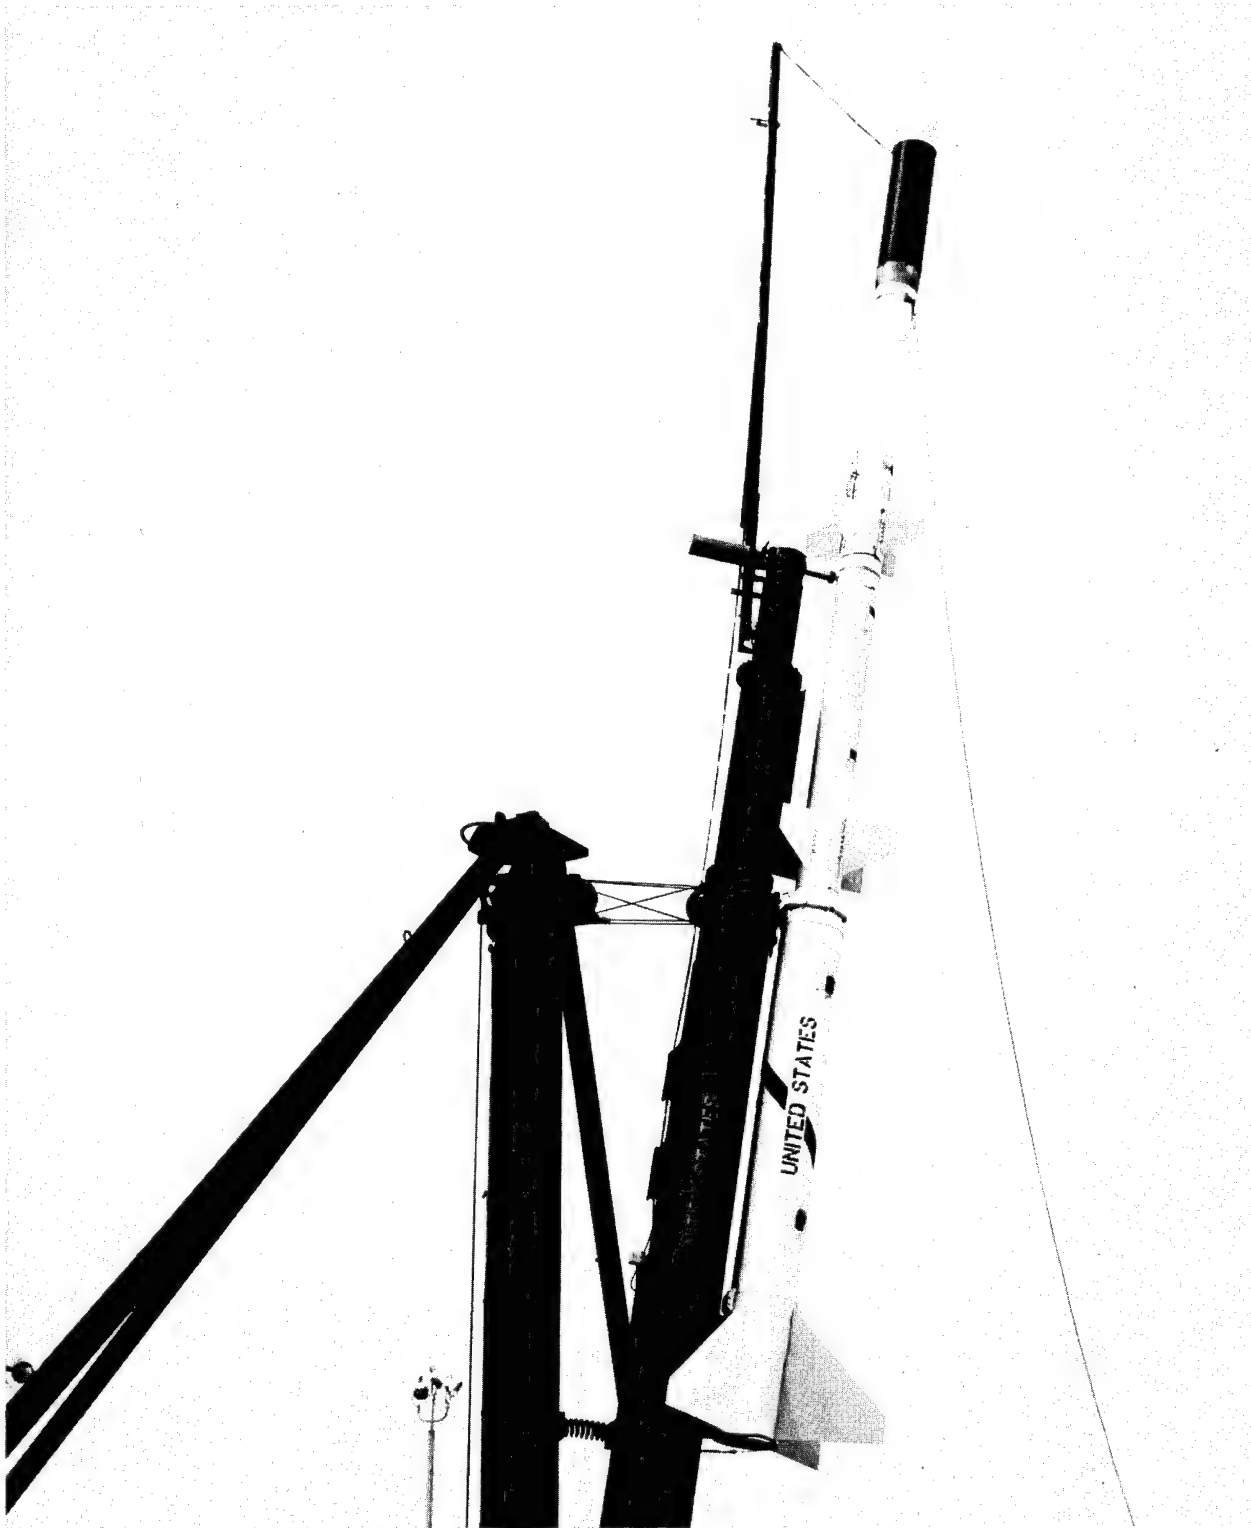
Figure 2.- Modified Javelin on launcher.

A modified Javelin vehicle was launched from Wallops Island, Virginia, on April 15, 1964, to flight test an Altair IIC1 (X-258) (S/N RH-65) rocket motor in a spinning environment similar to that of the Scout vehicle. The primary objective was to obtain flight-performance and temperature data to correlate with AEDC static tests. Modification of the basic Javelin vehicle consisted of substituting the Altair-IIC1 as the fourth stage in place of an Altair-IA6 with the other stages remaining the same (Honest John, Nike, Nike). Figure 2 shows the vehicle on the launcher.

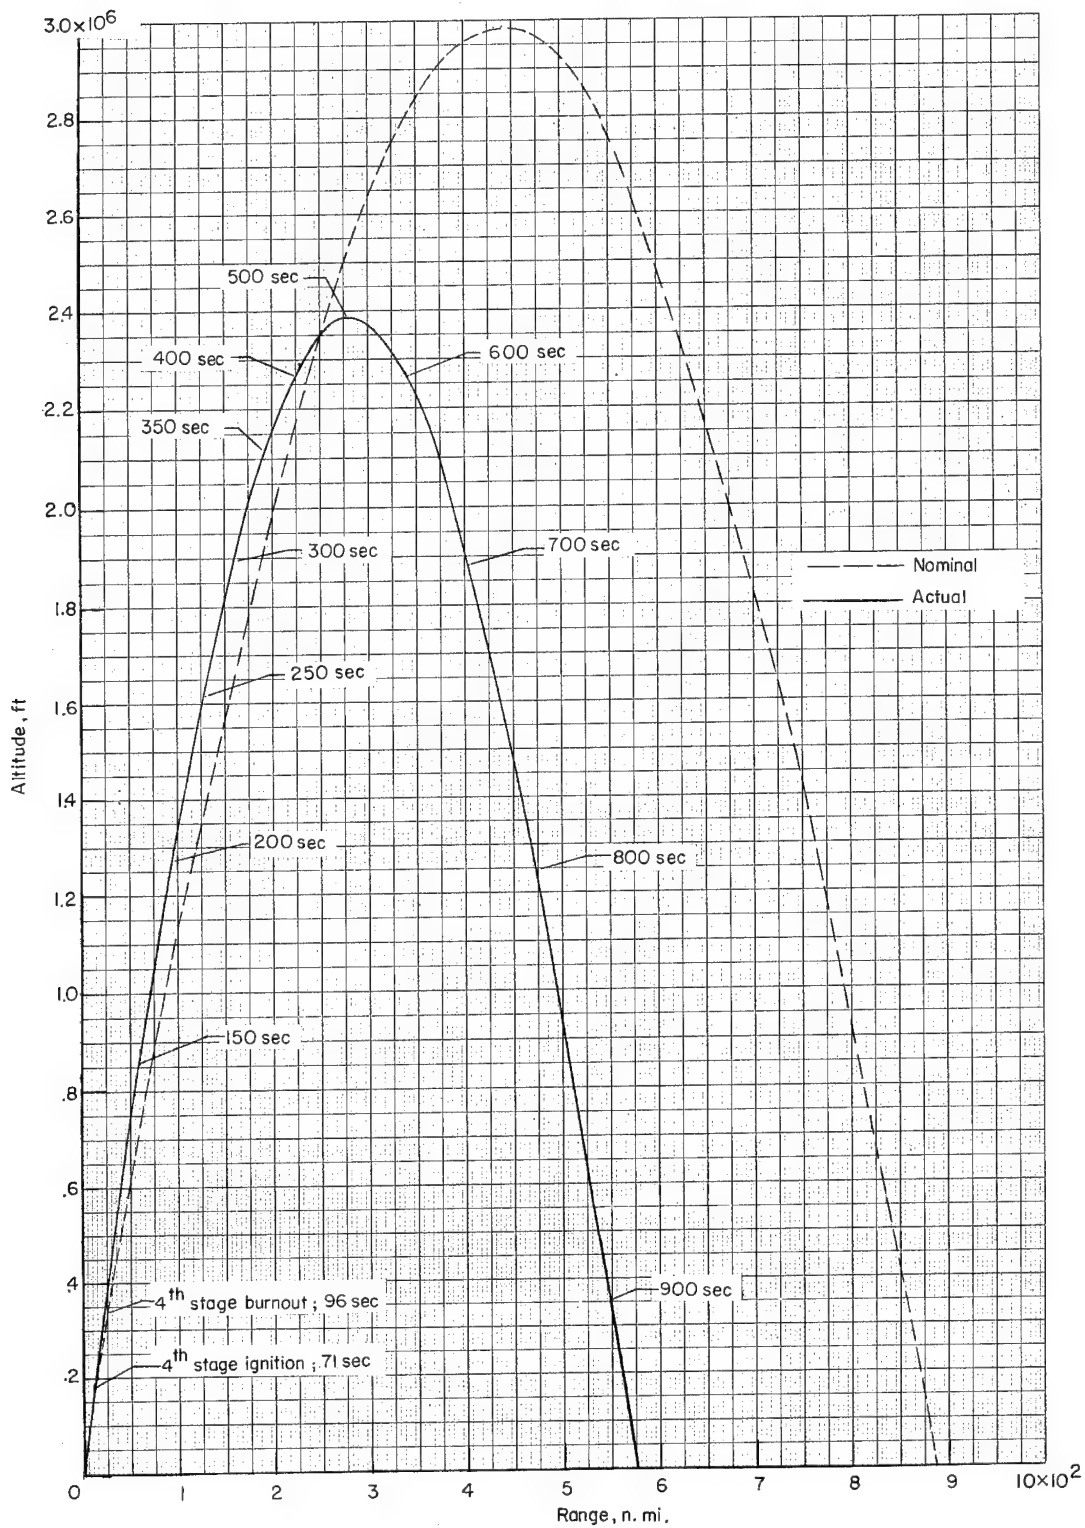
Figure 3.- Comparison of actual and nominal flight path.

Figure 3 shows a comparison of the actual and nominal altitude-range plot. Failure of the fourth-stage heat shield to eject at the proper time resulted in a performance level lower than expected. The heat shield did eject as noted in table I where actual flight events are compared with nominal event times.

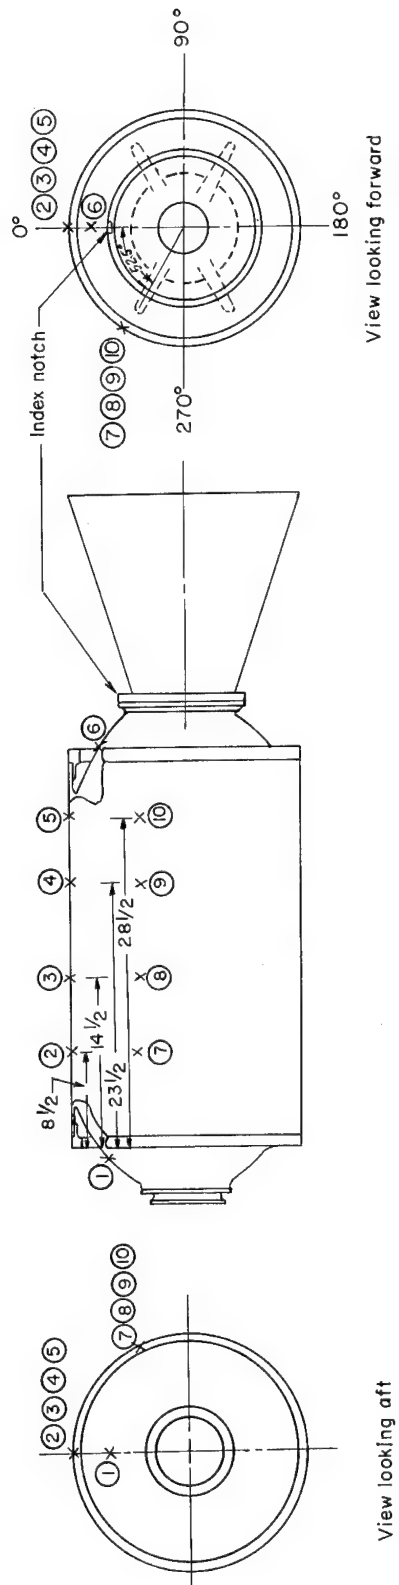
Figure 4.- Temperature-sensor locations. All dimensions are in inches.

Instrumentation in the payload for monitoring performance is listed with respective ranges in table II. Figure 4 shows schematically the location of the 10 thermistors which are of primary interest in this report. Figures 5 to 7 are photographs of the actual thermistor locations on the flight motor.

Figures 9 to 13 compare the results of the flight test and of the static altitude tests. As indicated in the figures, the flight motor had silver conductive paint on the forward dome but was natural elsewhere. Examination of the data for thermocouple (TC) 4 in figure 11 indicates that the addition of an aluminum-foil wrapping to a natural case can increase the maximum temperature of the case from 400° F to 700° F. It should be noted that for TC 4 the maximum temperature for the foil-wrapped case occurs 150 seconds after that for the nonwrapped case. Similar results were observed during the static test of an Altair-IIIB1 (S/N RH-47) motor tested at 200 rpm as indicated in reference 2. Examination of the Altair-IIIB1 motor after testing showed a large deposit of resin on the aluminum foil. As a consequence of this resin boiloff, the fiber-glass filaments in the chamber midsection were left essentially unbonded. This condition resulted from a case surface temperature of 700° F measured over a grain slot (fig. 4).

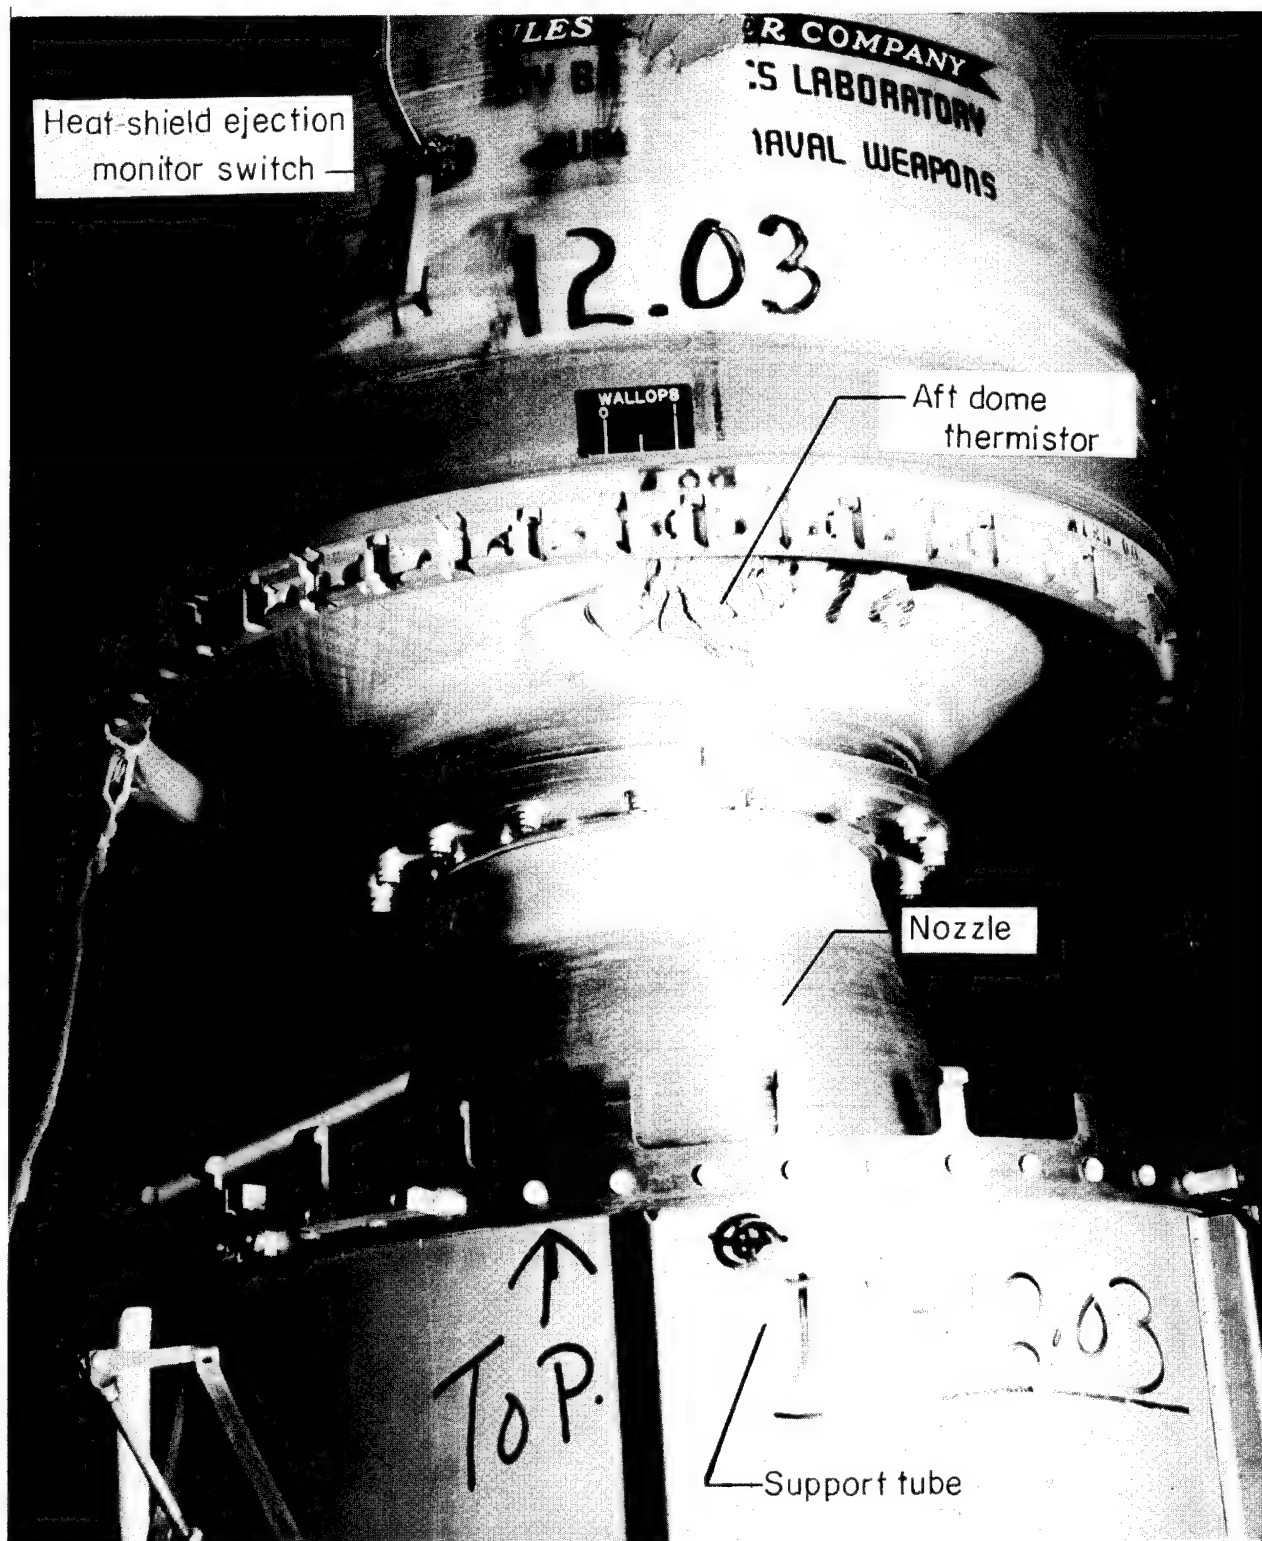
Figure 5.- Altair-IIIC1 instrumentation (aft end).

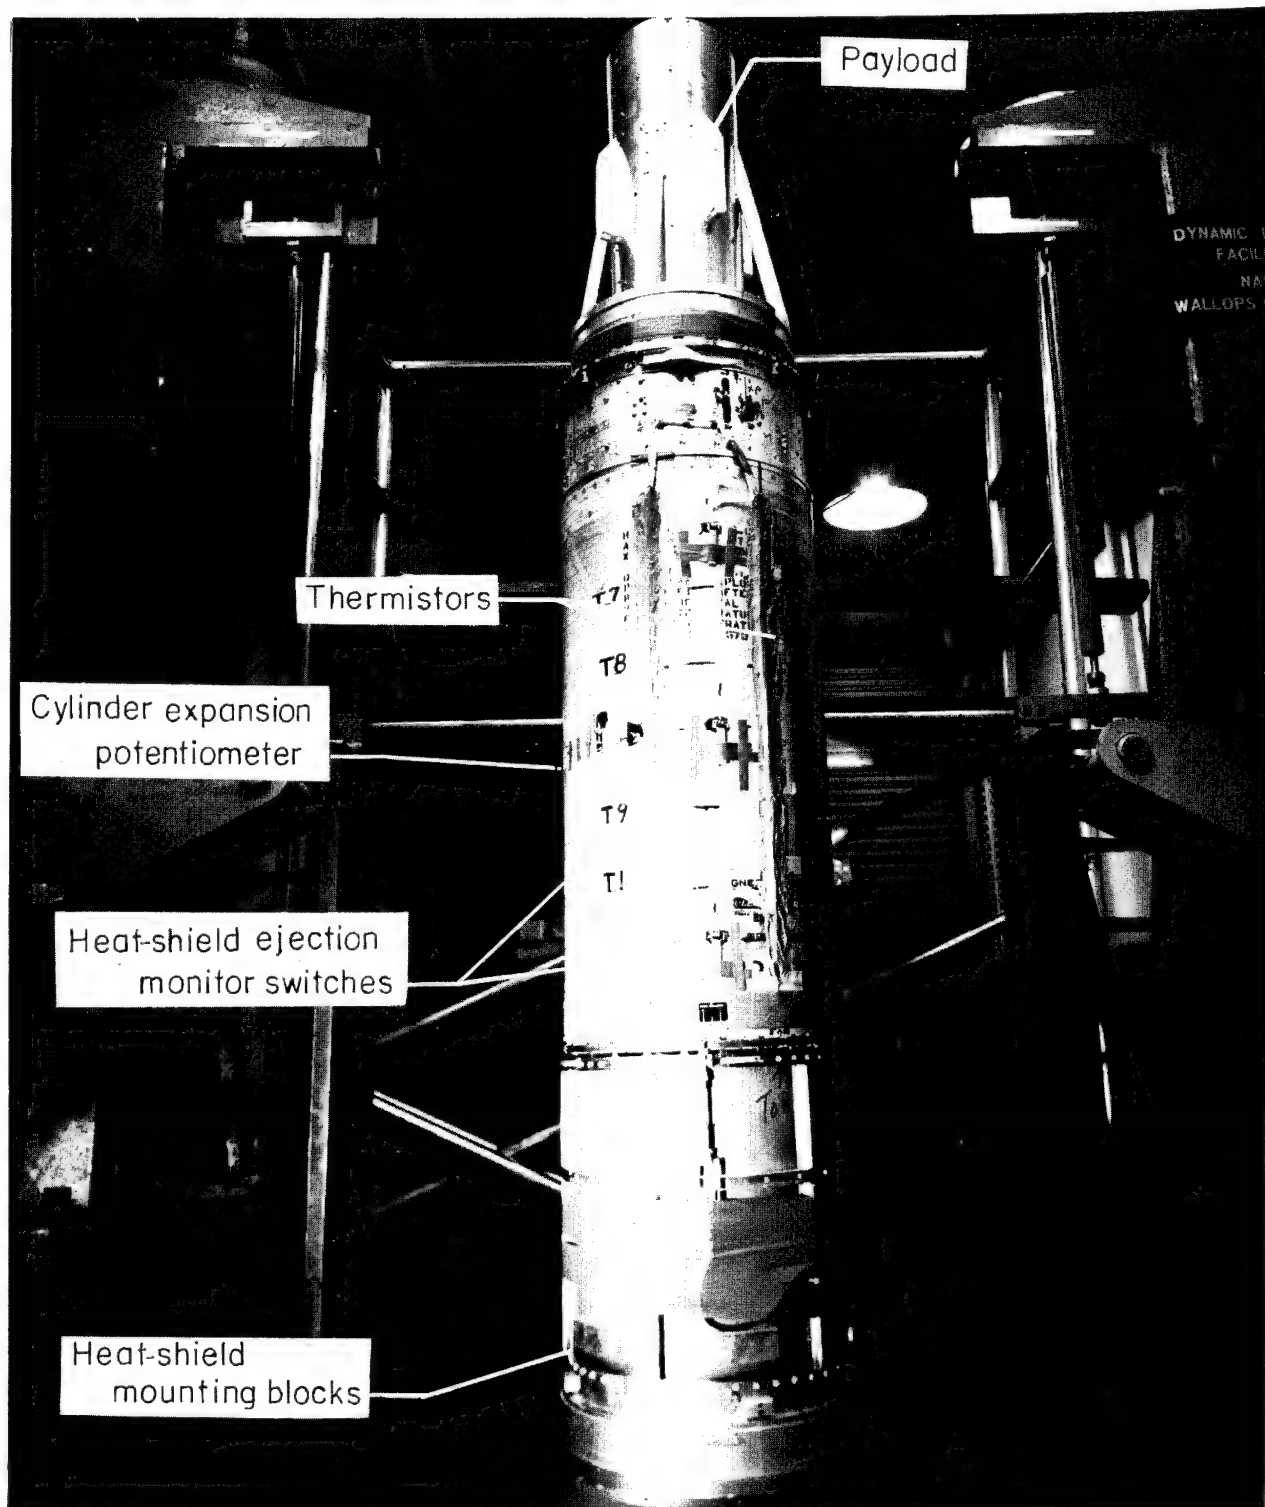
Figure 6.- Altair-II01 payload stage.

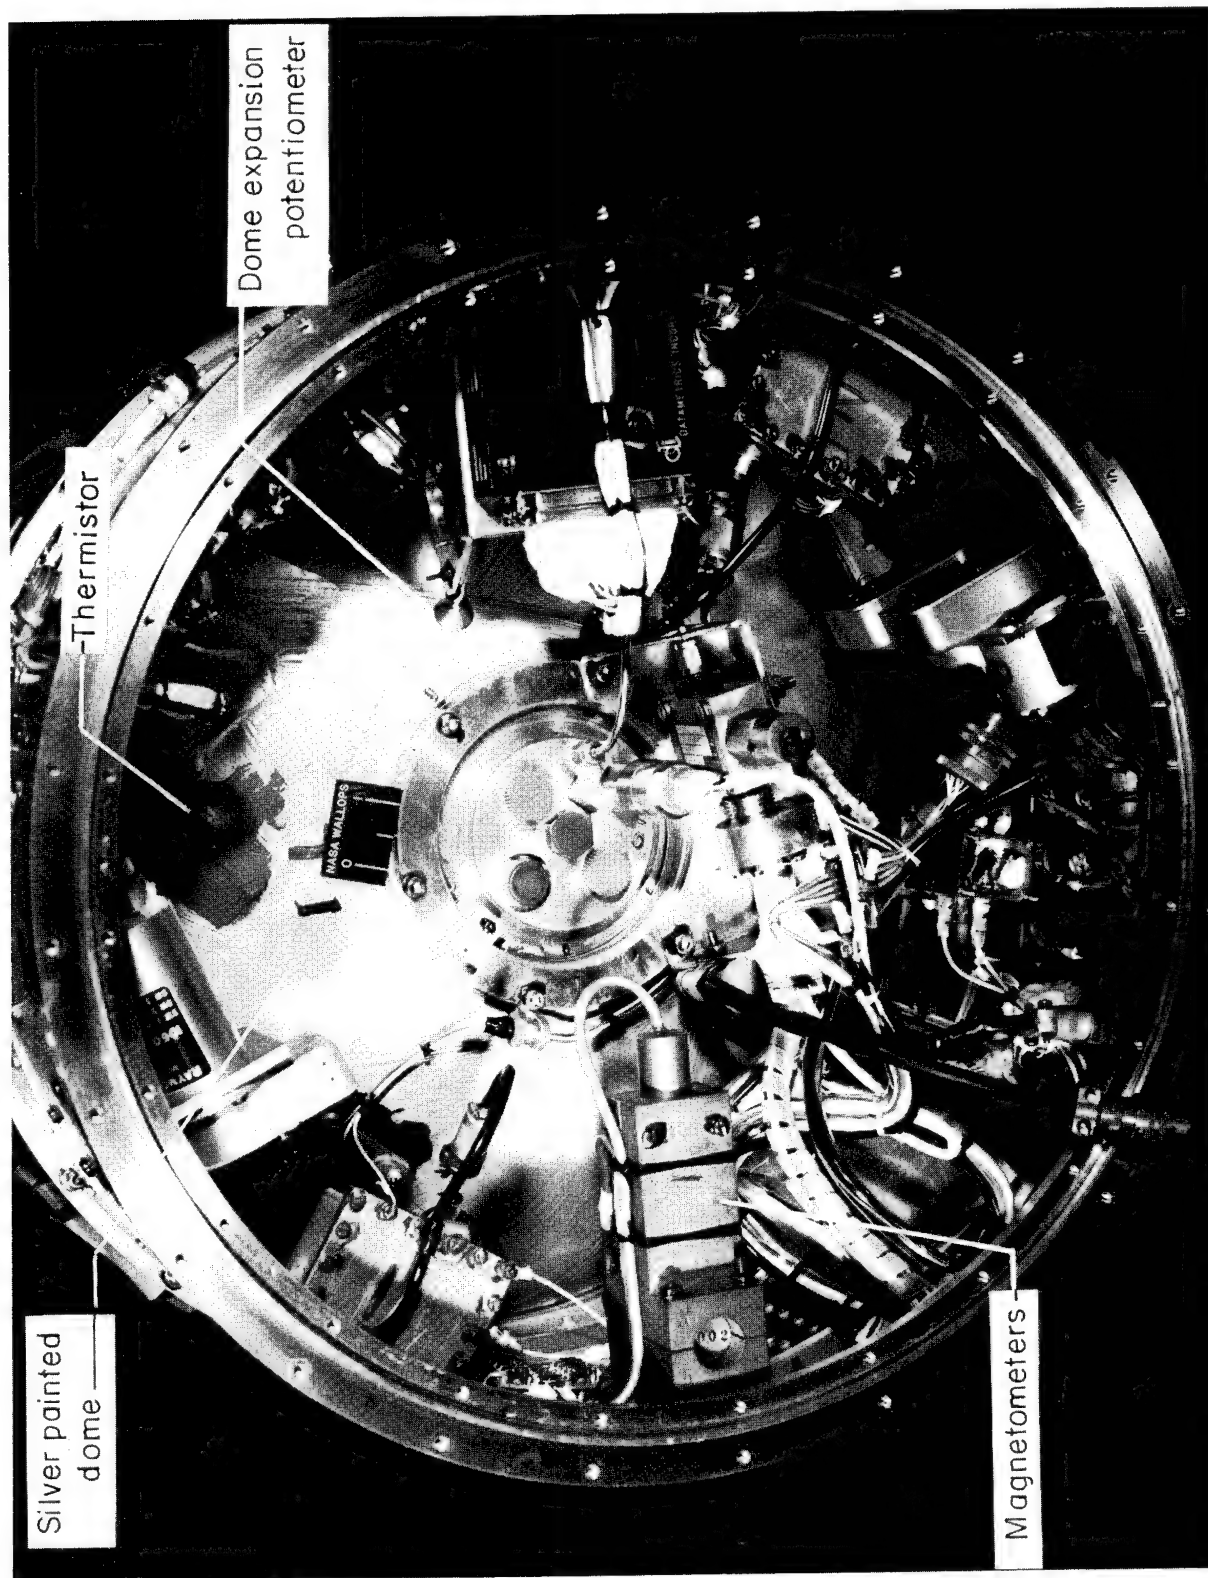
Figure 7.- Altair-IIIC1 instrumentation (forward end).

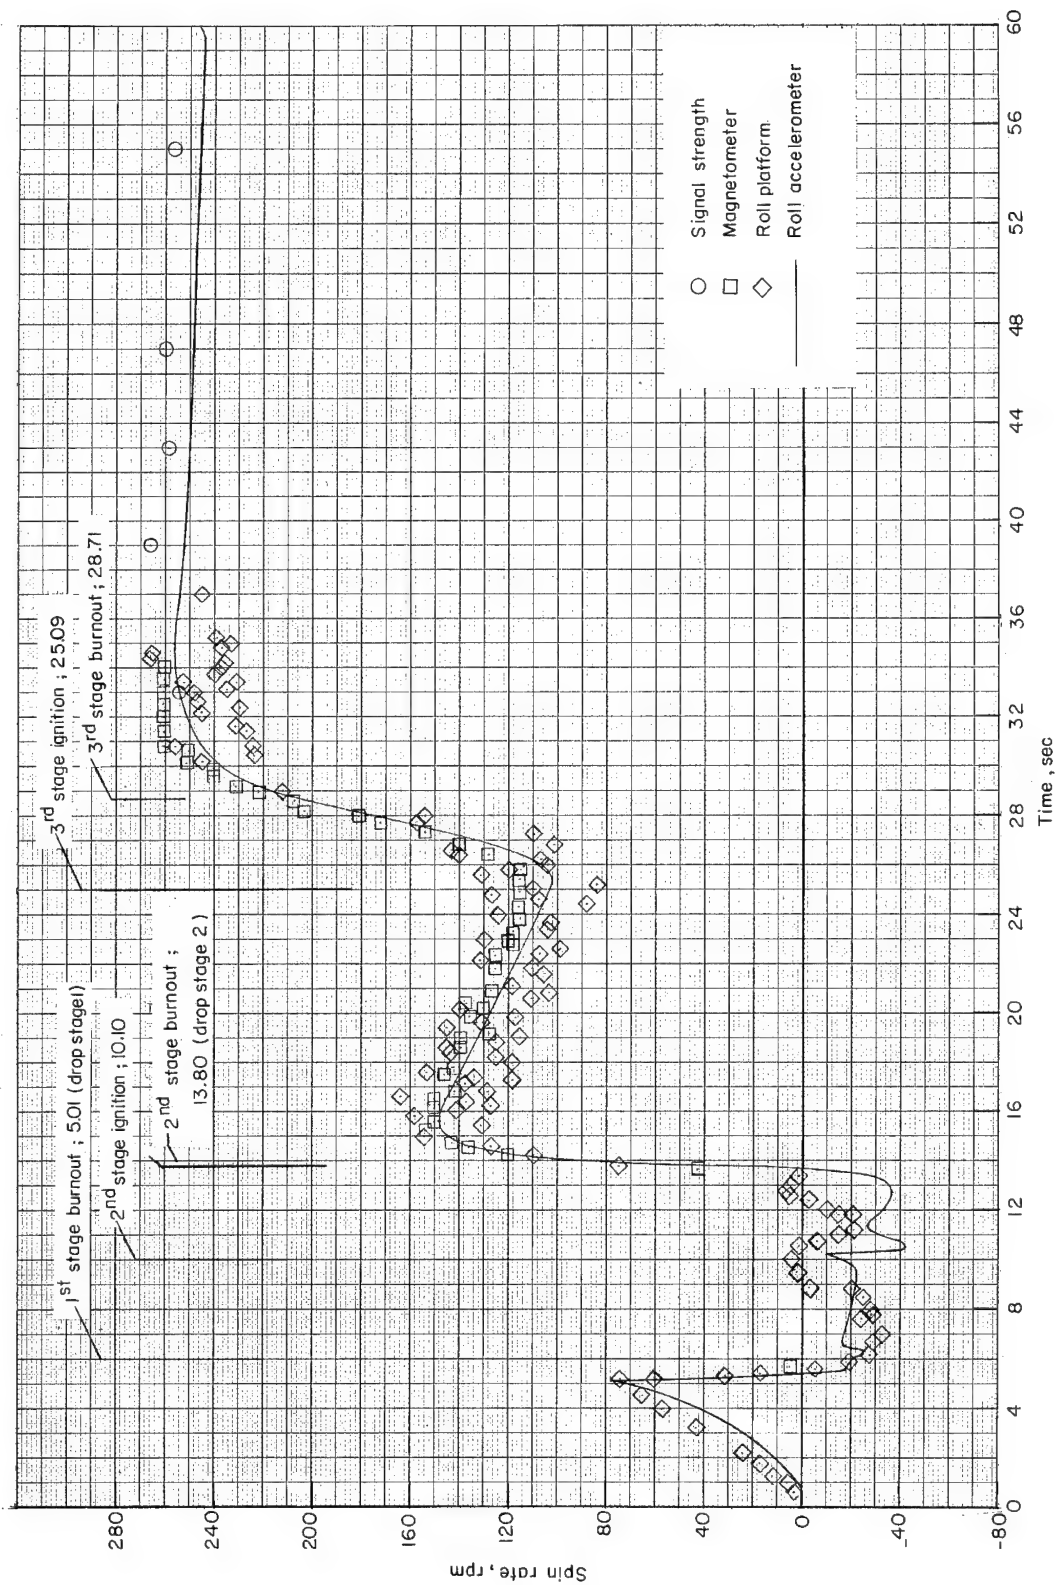
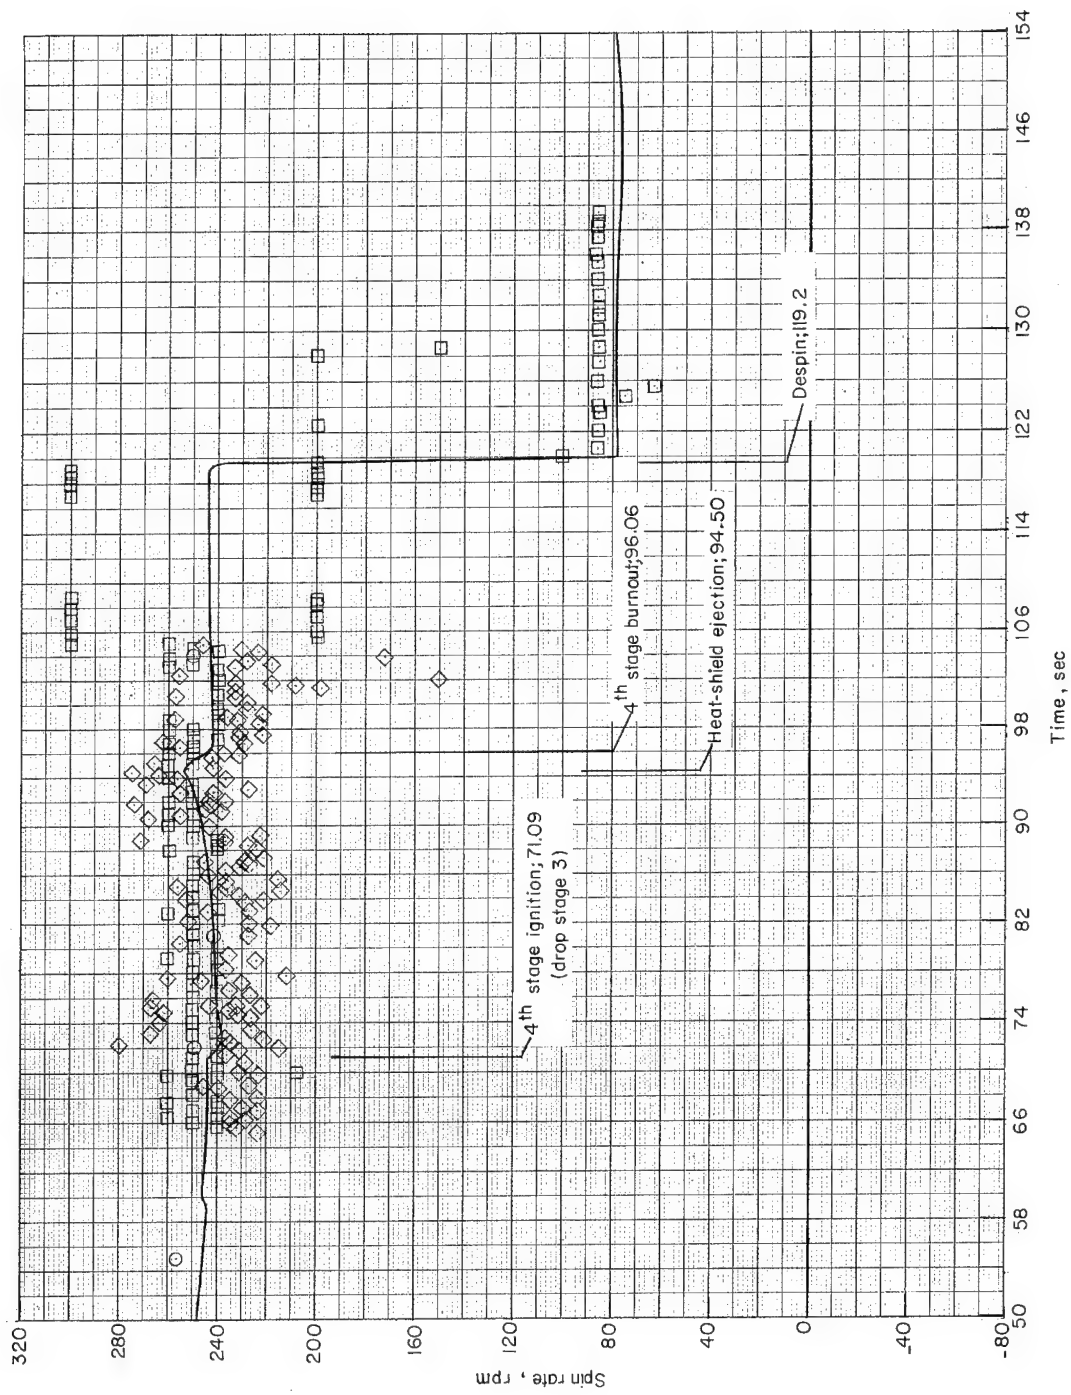
Figure 8.- Concluded.

Figure 8.- Comparison of spin rate obtained from various sources.

A prime requirement for the flight test was to have a spin rate equal to or slightly greater than that of Scout during motor burning. The spin rate was produced by canting the first-stage fins 30 minutes and the third-stage fins 37 minutes. Since spin rate was deemed to be a primary measurement it was measured by several instruments and the results are shown in figure 8.

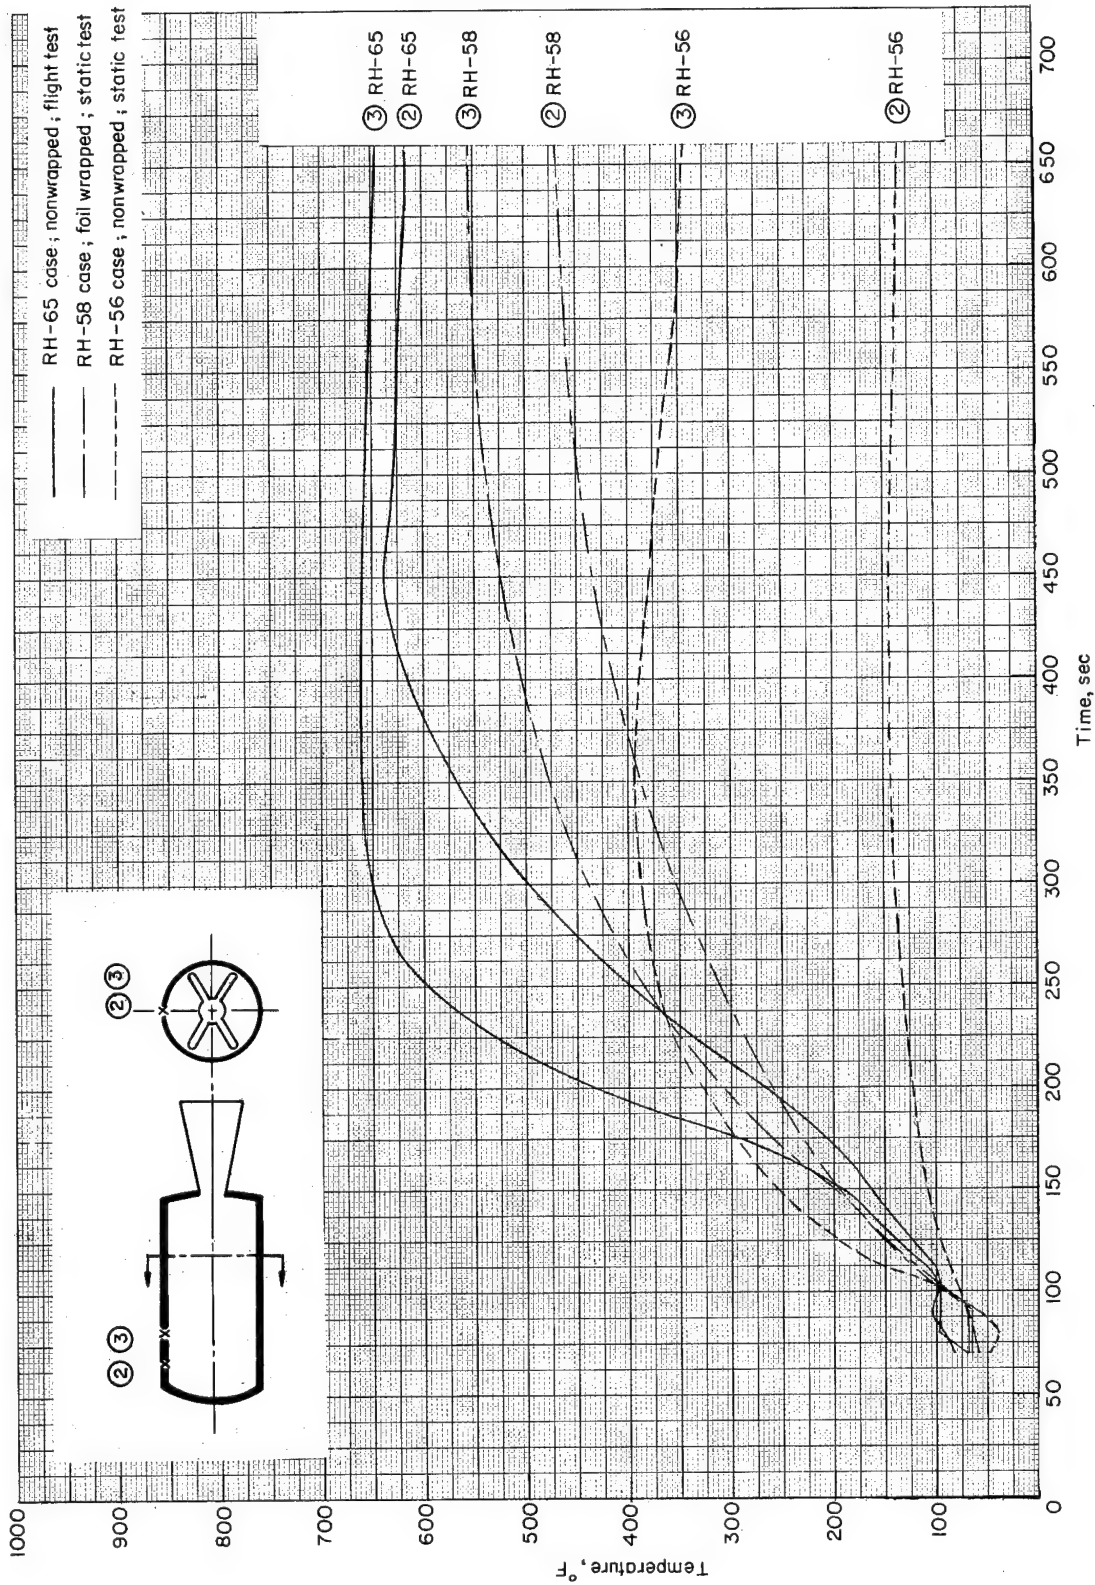
Figure 9.- Forward-cylinder temperatures measured at thermocouples 2 and 3.
